Bank Restoration of Walton Creek

**By
Robbin B. Sotir**

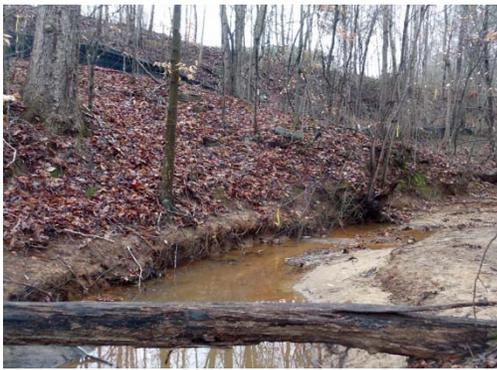
The Walton High School is located in Cobb County, GA in the City of Marietta has a lovely little stream. In 2005, the stream on Walton High School property was showing little evidence of negative impact from storm water events, despite the fact it is located in an area bounded by the school buildings, athletic track, parking lots, neighborhoods, and streets. The water was clear and the stream had a well armored cobble stone bed. The stable stream banks were heavily vegetated with native ferns and mosses. The stream is located within the Sewel Mill Creek Basin and is part of the Chattahoochee Watershed. The STEM AP classes used it as an outdoor classroom monitoring the water quality in participation with Cobb County's Adopt-A-Stream program. Around 2011, a pair of beavers built a dam across the stream causing it to back up and pond, however it remained stable. The beavers were discovered by employees of the County, who quickly demolished the dam. The beavers left, but the formerly ponded area was now exposed. With every rainstorm the stream banks suffered severe erosion, sending tons of sediment pollution downstream. Sediment also deposited over the cobble stone bed, destroying habitat.

Figure 1. Eroded and undercut streambank.

Due to the extensive and increasing erosional damage, loss of aesthetics and habitat degradation to the stream and stream banks, it was decided restoration would be beneficial. To achieve this a project-based learning assignment was developed for the ninth-grade STEM AP Environmental Science students to undertake this effort.

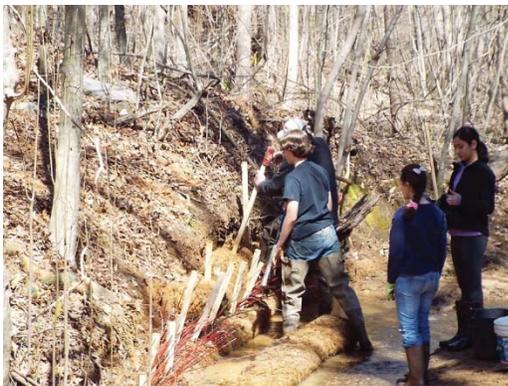
Over a two-day weekend in March 2015, the students worked on the creek to construct the project. First, they installed the high left outside meandering bank with superlogs, these were anchored with stakes. Additional superlogs were placed on top of the first row, and shrub dogwood and willow

container plants and cuttings were installed between the two layers of superlogs to protect the bank by reducing near bank velocities. The BioD-Mat 70 woven bristle coir fabric was placed on the bank above and was planted with native ferns to control surface soil erosion. River rock was used to fill in a hole that had formed in the downstream area along the bank at the end of the superlog installation. Native ferns, irises, and cardinal flowers was installed on the opposite inside bank over the BioD-Mat 70 blanket to control erosion.

Figure 2. Students installing the natural coir products.

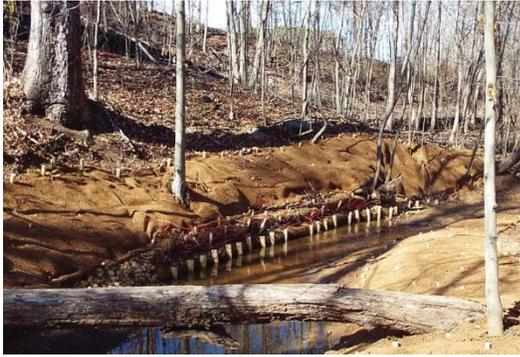
Figure 3. After successful installation.

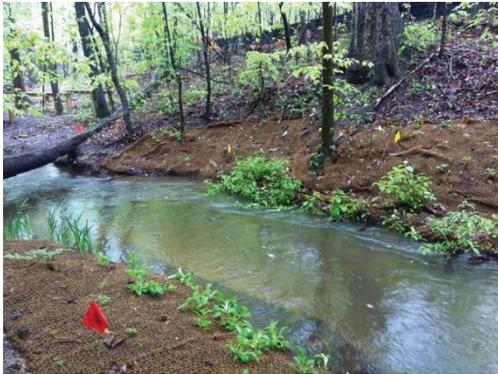
The students enjoyed themselves, worked hard and were very energetic restoring over eighty-five feet (85') of stream bank. The stream restoration project has been very successful. First it is doing a great job of protecting the stream banks from erosion. High storm water events are being properly channeled and bank erosion has stopped. The plants have grown and filled in much of the coir blanket and the area between the superlogs. Secondly, and perhaps more important this project has and will continue to teach these young adults the importance of caring for the environment and specifically urban streams.

Figure 4. Two months after installation.
