Coir Fibers Help Strengthen Environmentally-Friendly Golf Course Stream Restoration Project

RoLanka International, Inc. 2004

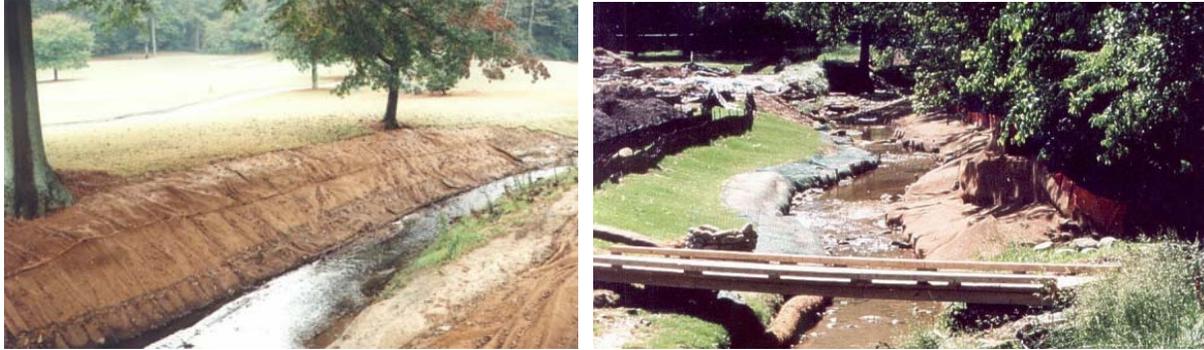
Bart and his crew used RoLanka's BioD-Roll coir rolls to stabilize the toe of streambank slopes. Made from coir fiber densely packed into tubular coir outer netting, the product is available in various sizes. In this case, 12-in. diameter, 10-ft. long rolls were installed along more than 7,000 linear feet of streambanks. With a design life of about five years, these logs resist the erosive force of stream flows to provide initial structural stability for the streambanks. Also, they are a growth medium. Over time, sediment will be deposited around the rolls to support riparian vegetation, planted in and around the coir rolls (logs), which will provide permanent erosion control.

In some cases, the TRMS were anchored to the coir rolls and used to stabilize the banks above the logs, before installing plants. Towards the end of the project, the TRMS protected bare areas above the logs over the winter until sod could be installed the following spring. "Once the logs filled with water, they became fairly heavy, providing a good base for tying the TRMs," Bart says. "They also prevented the mat from being undercut by the stream."

In many areas, smaller perennials, including ferns and cardinal flowers, were planted directly into the logs. In others, sod was installed directly on top of the logs. "Although the logs are pretty stiff, they were flexible enough to bend around most of the contours in the stream," Bart says. "Sometimes, instead of reshaping all of a bank, we were able to push the logs into undercuts to provide an anchor for the TRMs before filling in behind the logs. The logs acted like shock absorbers to prevent damage to the TRMs from the impact of some fairly heavy debris in the flowing stream."
