# Hobson Creek Restoration Project, Oakbrook, IL

RoLanka International, Inc. 2004

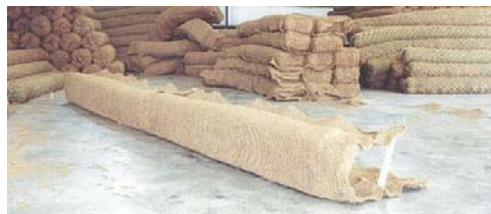
Last fall, Ted Gray and Associates, Inc., a stream and lake management and restoration firm in Oakbrook Terrace, IL, became one of the first in the Midwest to use a recently-developed biodegradable system of densely-packed coir blocks and woven coir matting to build an environmentally-friendly vegetated wall for stabilizing streambanks.

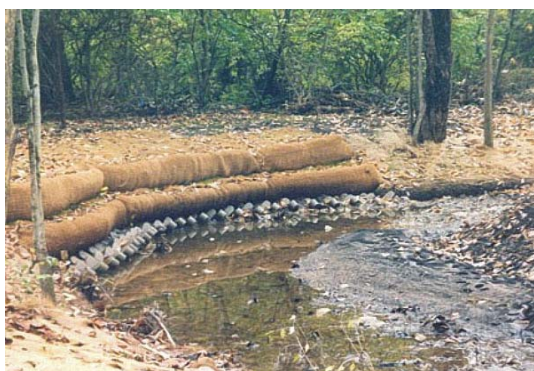
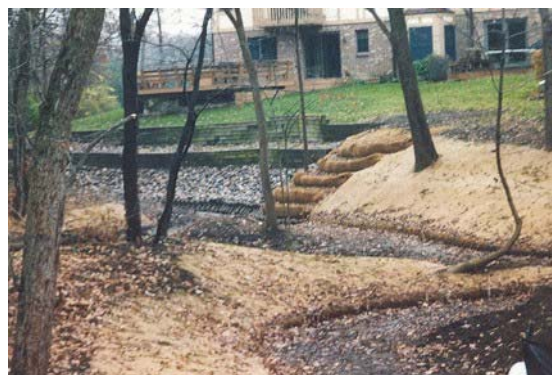
were awarded to Landscape Resources, Inc. Rock riffle grade control structures were installed to prevent further downcutting of the stream channel. After reshaping the eroded streambanks to a 3:1 (H:V) slope or flatter, 12-in. diameter densely packed coir rolls, (BioD-Roll made by Rolanka) were installed in a 6-in. trench and secured with 2-in. diam. wood stakes fastened with 1/8-in. cord to provide structural support for the toe of the slopes. In other areas where more severe erosion occurred, one to three rows of concrete a-jacks were used to stabilize the toe of slope. BioD-Block was then installed in layers directly above the fiber roll and/or a-jacks. Averaging two to three blocks high, but ranging up to five blocks high in some places, the layers were stepped back to produce a finished wall face with about a 2.5:1 slope.

The coir fabric attached to the BioD-Block was staked in place behind the blocks. The contractor devised a strategy to tie the top of the blocks and anchor them to the slope with wooden stakes. “We added these tie backs as extra insurance to prevent any of the blocks from overturning until the establishment of native plantings at the site,” Gray says. The coir wall system was then backfilled and planted with a native plant seed mixture. Various types of native plantings were specified for each site depending on the level of sunlight exposure and the anticipated erosive forces. For instance, in the less-eroded sites that received more sunlight, herbaceous 2-in. diam. plugs such as switch grass, fox sedge, or cord grass were installed. In the more highly eroded areas, shrubs were installed including dogwood, willow and viburnum along with native plant plugs along the top of bank.

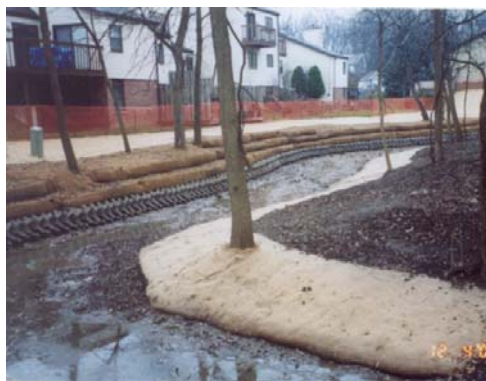
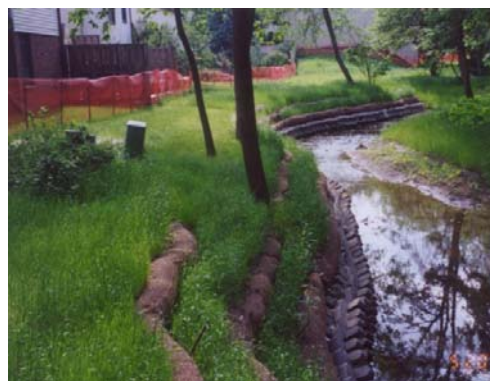
As of August, the BioD-Block re-constructed slope remained fully intact. “So far, it’s performing very well,” Gray says. “Our intent was to design the slope so that in the future, when the materials biodegrade, the slope will be vegetated at a stable angle. The big test will be in about three years after the coir material degrades and the plant roots are stabilizing the slopes. Then, we’ll know exactly how the project performed. Based on results thus far, I think it will work out well.”
