## Soft Bank Stabilization Works: A Case Study

Lanka Santha, P.E.  
Calista R. Santha, P.hD.  
RoLanka International, Inc.

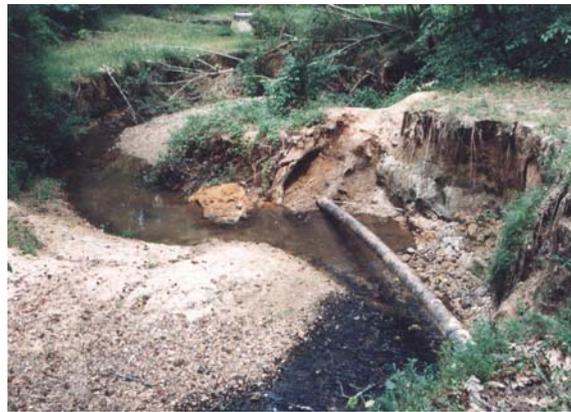
The Joe R. Adair Outdoor Education Center (OEC) is located in Laurens, South Carolina. Flowing through the center's property is a stream that carries large volumes of water from local rains. Development in the surrounding areas significantly increased the runoff to the creek which increased the stream flow volume. As a result of this increase, about 100 ft length of the stream bank suffered a major failure exposing a 20 foot length of natural gas pipeline. Every major storm accelerated the streambank erosion. Since the natural gas pipe line was exposed, the Laurens' Commission of Public Work (CPW) was very interested in repairing the problem area.

**Figure1. Eroded site**

Civil engineering consultants to the CPW came up with plans to correct the problem. Recommendations included covering the entire problem area with large stone rip-rap. The OEC staff did not favor this plan and requested a soft solution for the eroded streambank. As a result, the city agreed to get assistance from a professional civil engineer knowledgeable in soil bioengineering techniques. The original engineering plans were modified to accommodate a soft approach, and large stone rip-rap was replaced with coir fabric encapsulated in soil layers with live willow cuttings placed between layers. This soft approach specified a minimum use of rock at the toe of the bank and a coir roll positioned on top of the rock layer. The design layout was developed with rock at the toe placed below the water level in order to avoid visibility.

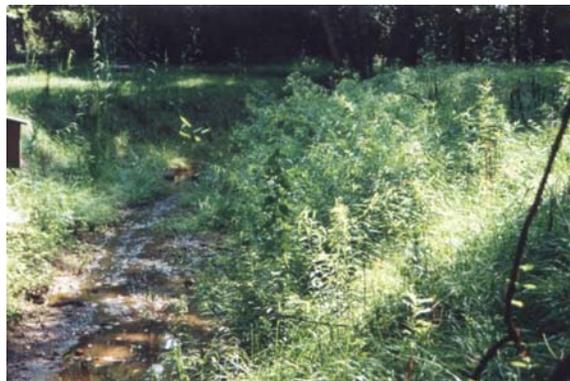
Construction of the project was completed the last week of July 1998. The major question to be answered was, can live willow cuttings survive the hot summer? Staff at the OEC faced the challenge and watered the reconstructed bank during August and September. After two months, the whole streambank was green and willows were growing very well. There were several heavy rainfall activities occurred during the first two months after construction and the reconstructed streambank held up very well. Members of the CPW were very pleased with the outcome of the project. The OEC is using the site as an educational tool to show the effectiveness of soft bank stabilization compared to hard bank stabilization methods.

**Figure 3. Two months after construction**
