The erosion of beach and dune that has been occurring immediately north of the center parking lot groin now directly threatens public infrastructure as well as private property. The current effort to reinforce the area consists of the placement of a "soft" biodegradable structure to buttress the remaining dune. While it does not solve the erosion problem, it should greatly reduce the loss of sand from the dune during storms.

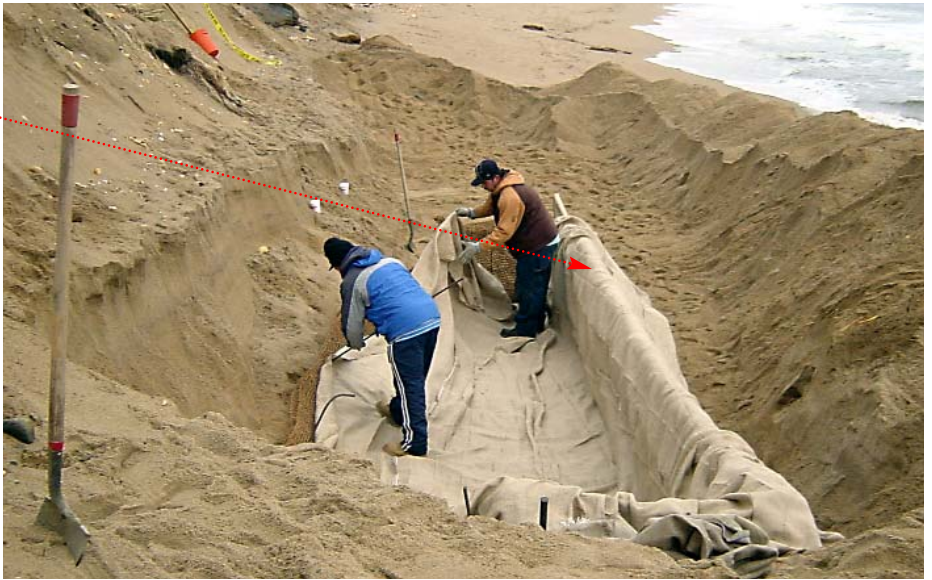
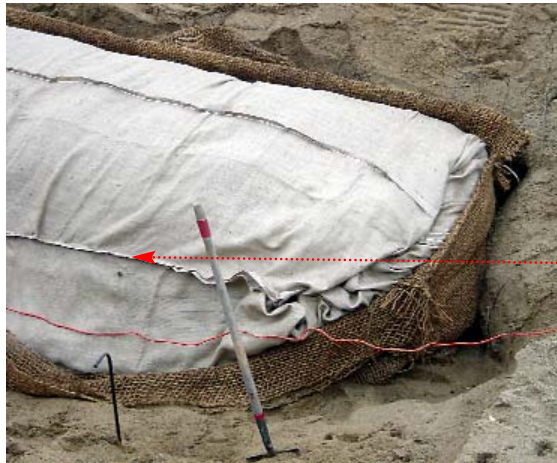
The installation process begins with a trench excavated in the beach. Along the seaward side plywood forms are positioned to form a wall approximately 4 feet in height. Two mats of coconut fiber (coir) are rolled into the trench with the right or seaward side draped over the plywood forms. Seen in this photo installers are positioning the inner liner of a finely woven burlap. Square end panels of both the coir mat and burlap are stitched to close the ends. This assembly forms the bottom, sides and ends of the tube. When completed a "BobCat" type front end loader will carefully fill the space where the workers are standing with sand.

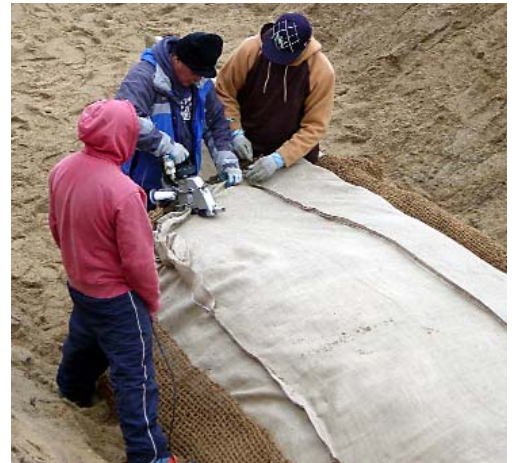
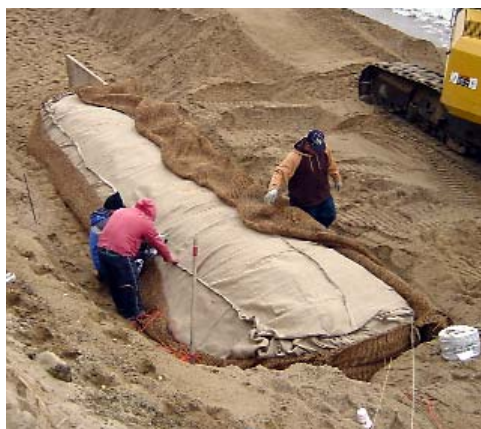
Once the sand has been added the burlap flap that had been draped over the form is folded over the sand and the shoreward edge of the burlap are pulled together and folded to form a seam. A portable electric sewing machine is used to stitch the seam closed, and then to close the ends. This image shows one end of the tube after it has been closed.

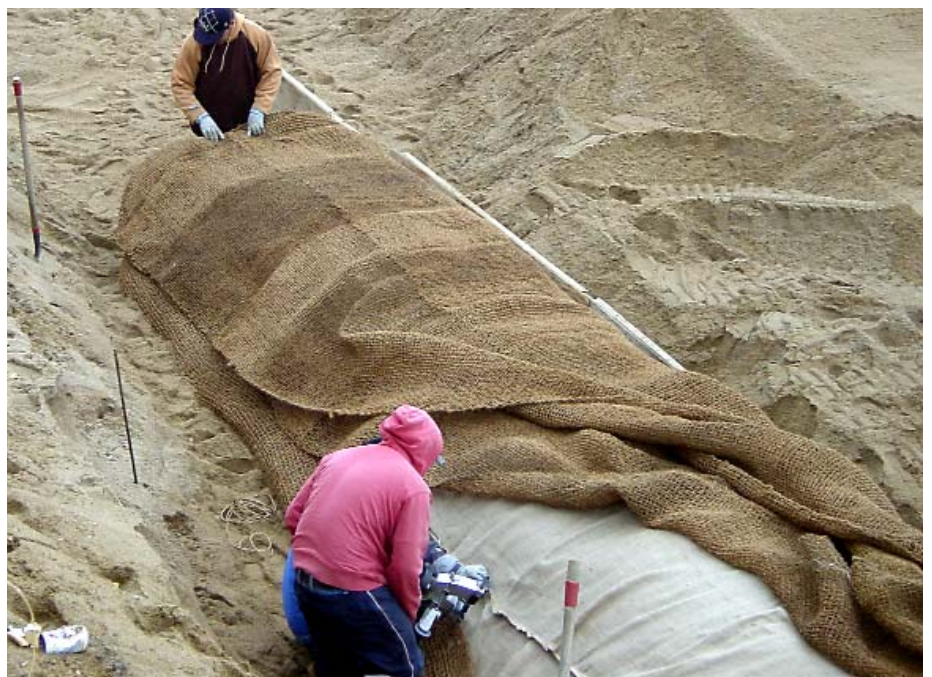
When the burlap has been stitched, the coir mats are pulled over and hand stitched together using long curved "needles" and coir twine of the same diameter as the warp and weft of the mat.

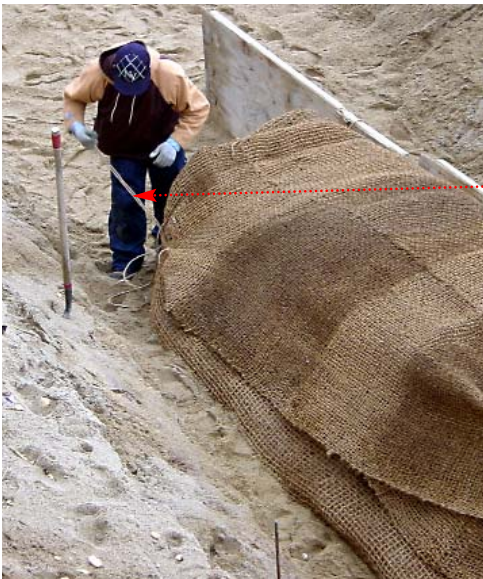
On the left the installer is seen stitching the end closed. Note the length of coir twine in his right hand.

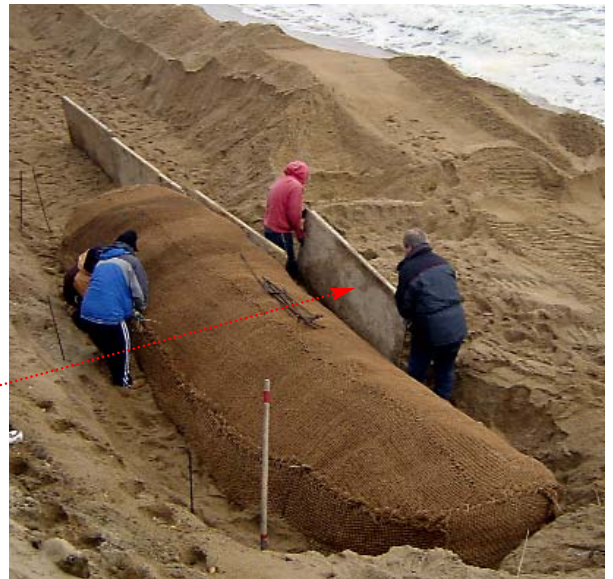
On the Right installers are seen completing the stitching of the outside coir mat, while two other installers are moving the forms into position to start another tube.

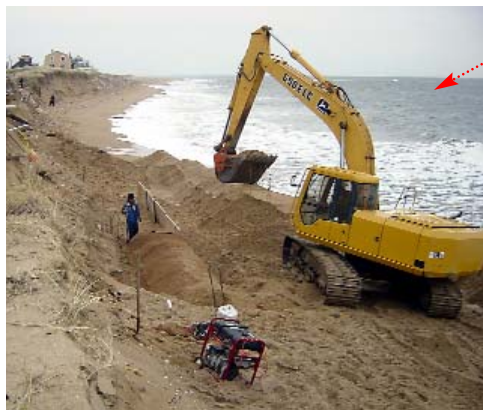
To the left the tube is being back filled with sand until it is completely covered. It abuts a tube on the near end that was placed earlier and will in turn abut the tube that will be placed where the forms are set at the far end. Eventually a second parallel line of tubes will be placed and these will form the base of the structure.

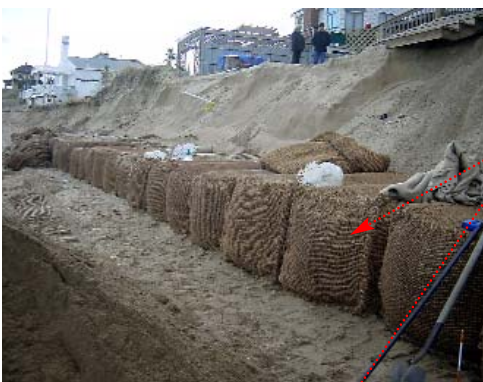
December 2, 2008, several additional tubes have been placed and a second team has started to the north constructing bags in a southerly direction. The second layer of tubes have been placed. These are 6 foot long and have been placed at a right angle to and on top of the tubes shown in the proceeding pictures.

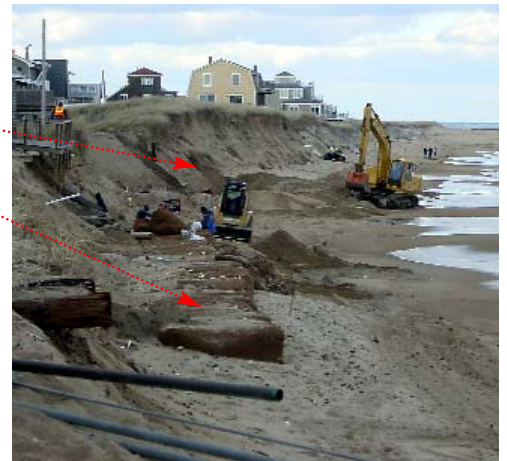
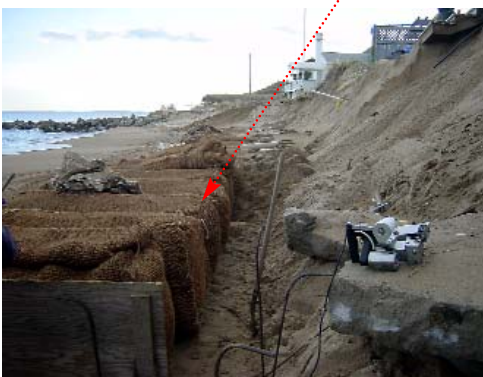
December 5, 2008 Installation of the second layer of 6' tubes has been completed to the northern terminis and is being extended southward to the groin.
